**FINAL  
REMEDIAL ACTION SUMMARY REPORT**

**117<sup>TH</sup> AIR REFUELING WING  
ALABAMA AIR NATIONAL GUARD  
BIRMINGHAM INTERNATIONAL AIRPORT  
BIRMINGHAM, ALABAMA**

**MARCH 1998**

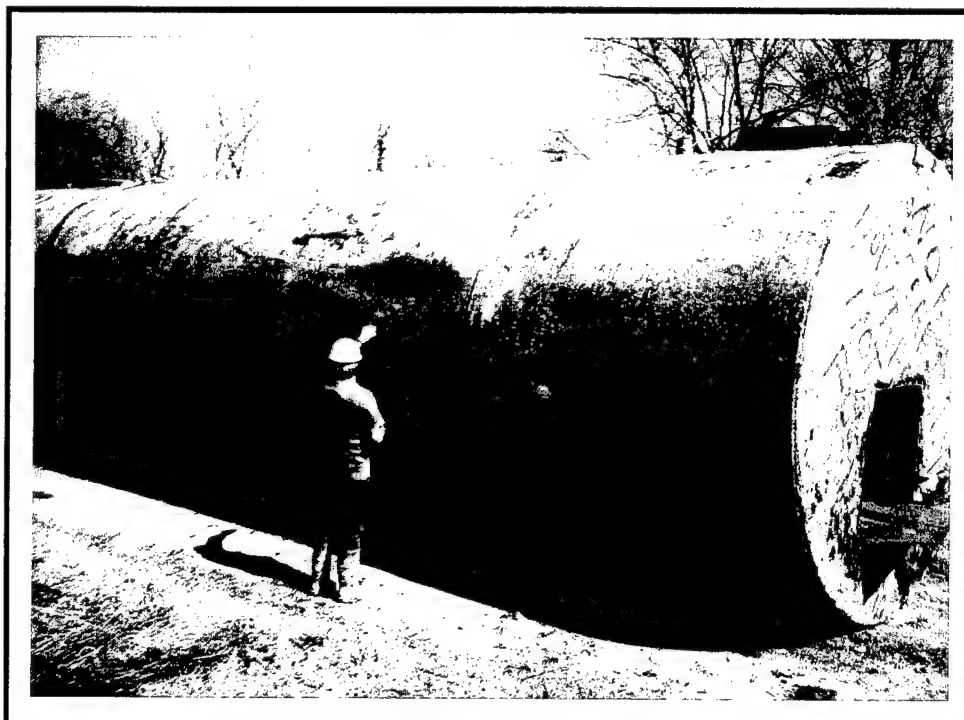
**Photo No. 2: 25,000-gal fuel tank being inspected at scrap yard.**

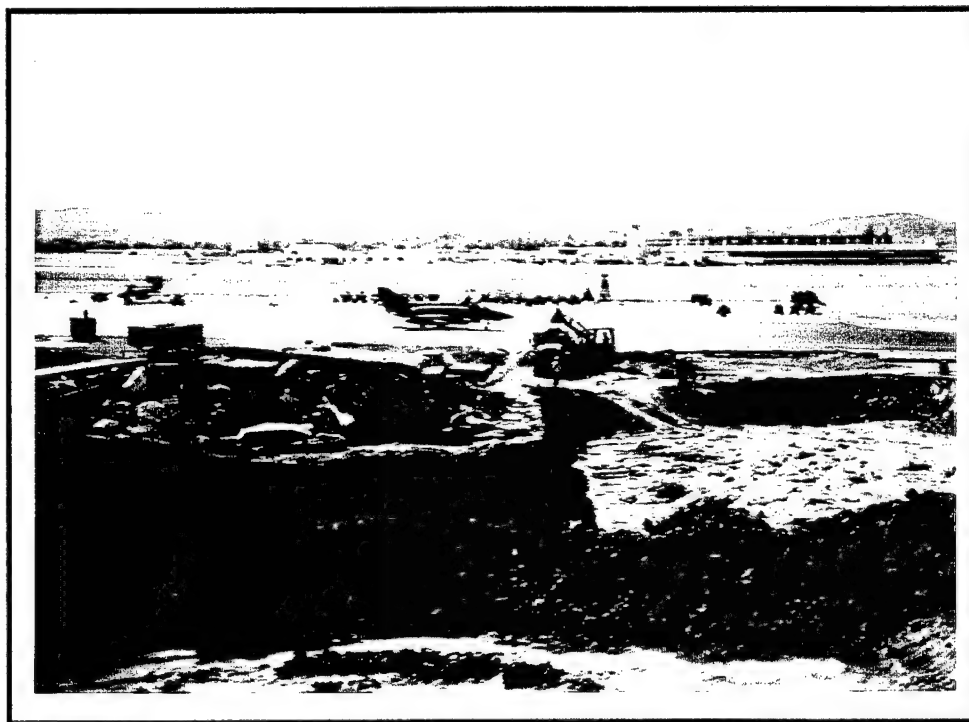
**Photo No. 6: Southward view of UST pit and overexcavated area.**

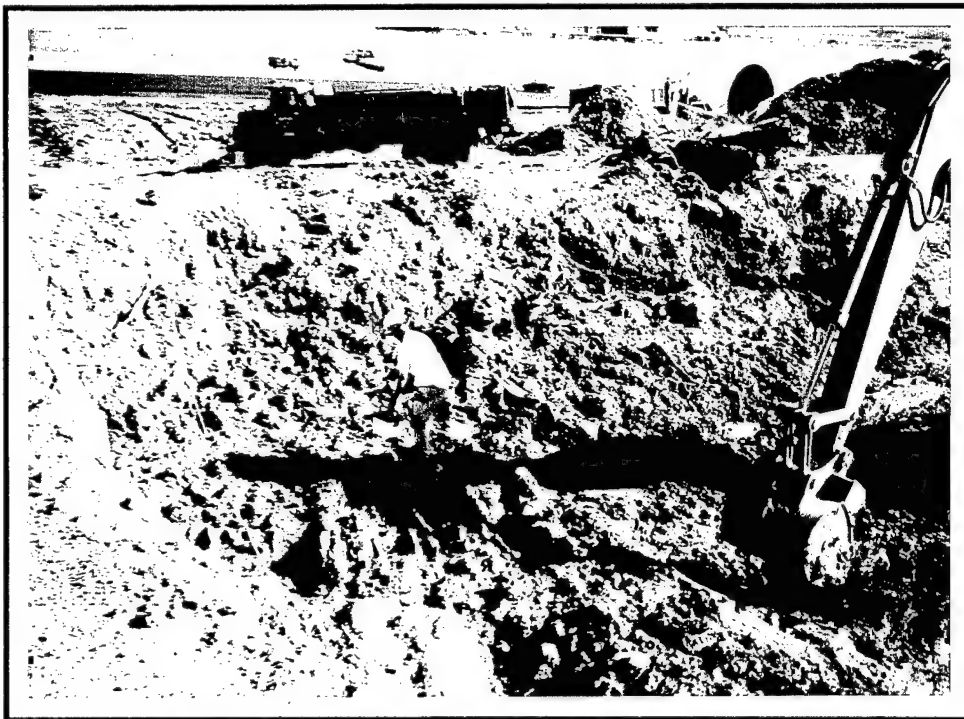
**Photo No. 7: Contractor (EMC) collection of soil samples.**

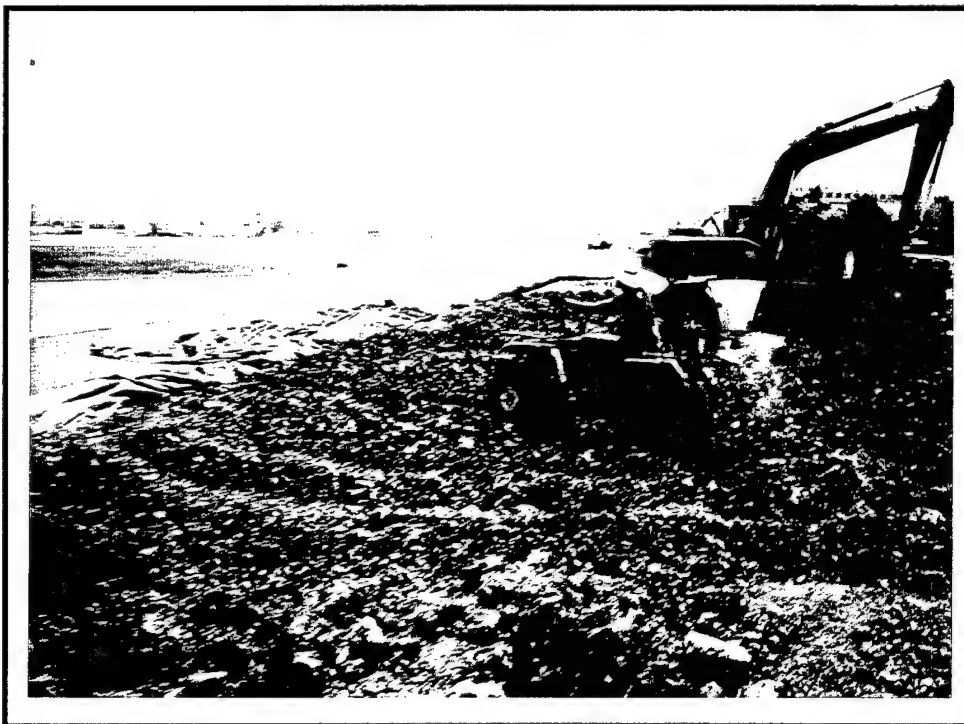
(Hydrobac S) at a quantity of 0.3 lbs/ yd<sup>3</sup> of soil. Nutrients for the bacteria were added at a rate of 3.6 lbs/ yd<sup>3</sup> of soil in the form of ammonium nitrate, diammonium phosphate, and potassium nitrate. An emulsifier (Polybac E) was added at a rate of 0.07 lbs/ yd<sup>3</sup> of soil to assist with thorough mixing. Additionally, water was added from one of the USTs (used as a holding tank) to the soils until the moisture content was between 15 and 20 percent. The soils were then tilled after treatment to ensure proper mixing of the soils with the additives. The soil bio-cells were covered with plastic sheeting during rain storms. Once the soils were tilled the second time, they were removed from the bio-cells and placed in a soil stockpile to make room for newly excavated soils. Plastic sheeting was used to cover the soil stockpile between soil additions, and was used to line the ground surface beneath the soil stockpile.

**Photo No. 8: Adding nutrients to the soils of a bio-cell.**

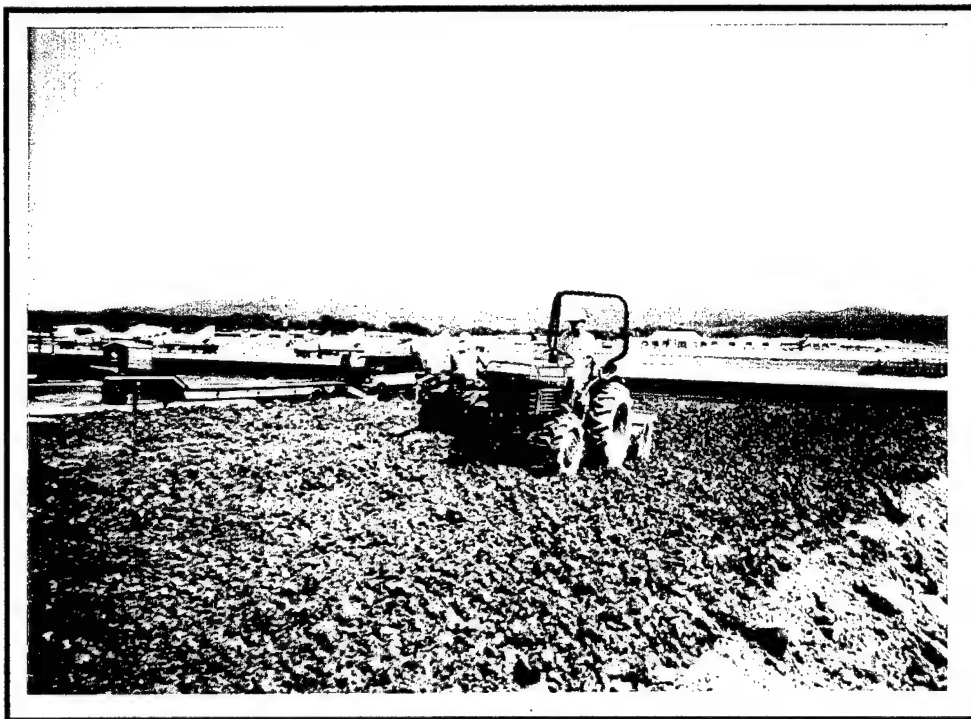
**Photo No. 9: Tilling of soil in a bio-cell.**

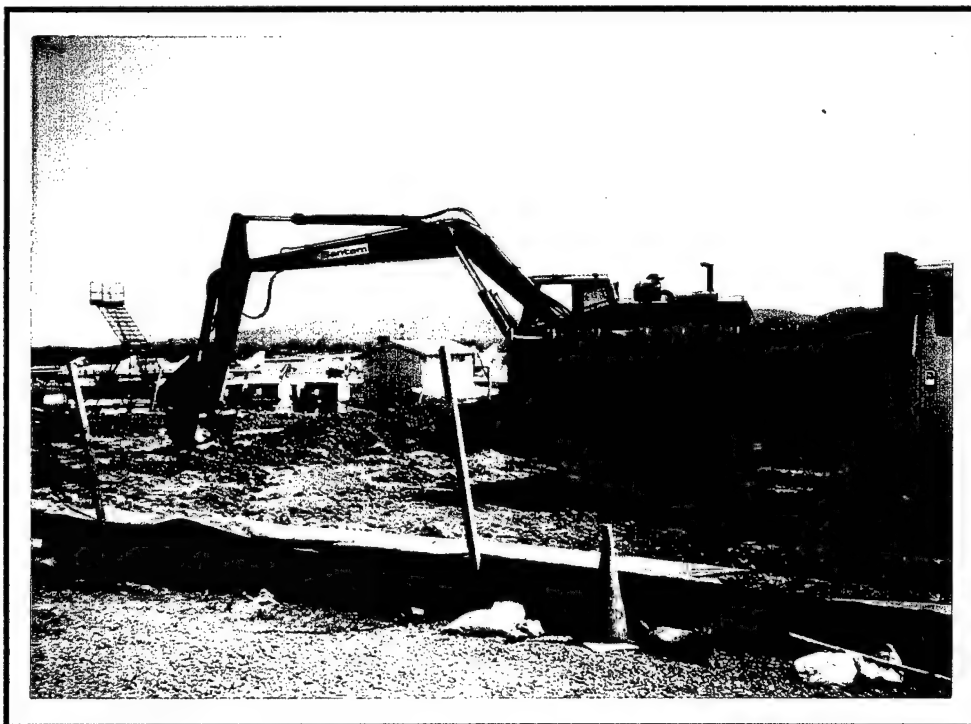
**Photo No. 10: Removing soil from a bio-cell.**

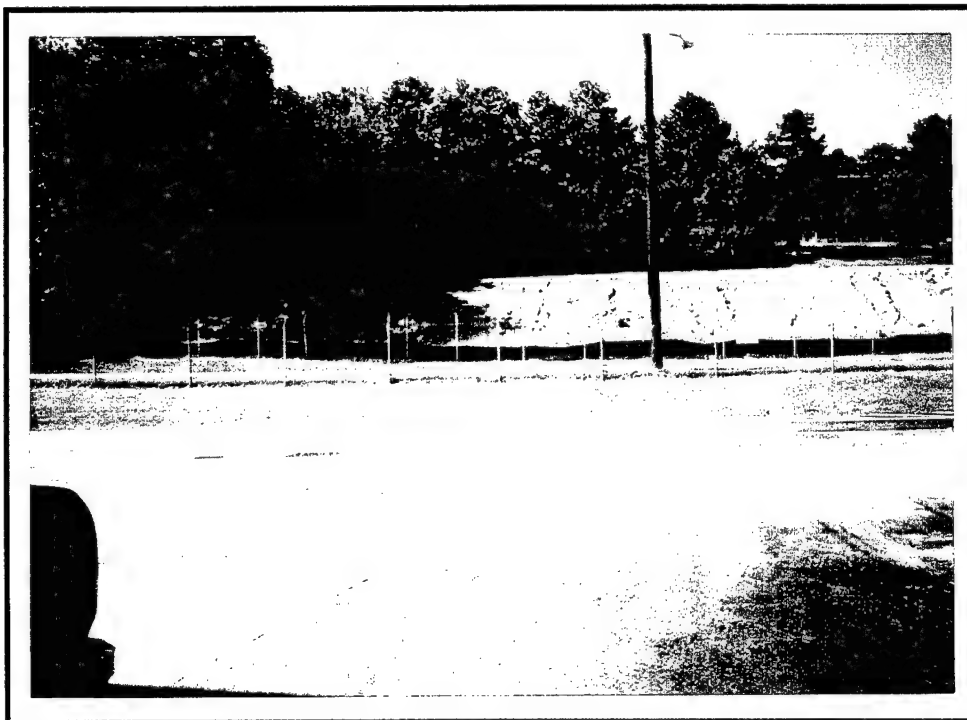
**Photo No. 12: Soil stockpile in the vicinity of Building 301.**
